Ernie Els Design
Nondela – Drakensberg Mountain Estate
Progress Report

On-Course Solutions site establishes at Nondela for Hydro-seeding, Bunker Stabilization and a Cart Path Trial Section

Site Establishment – March 30, 2009

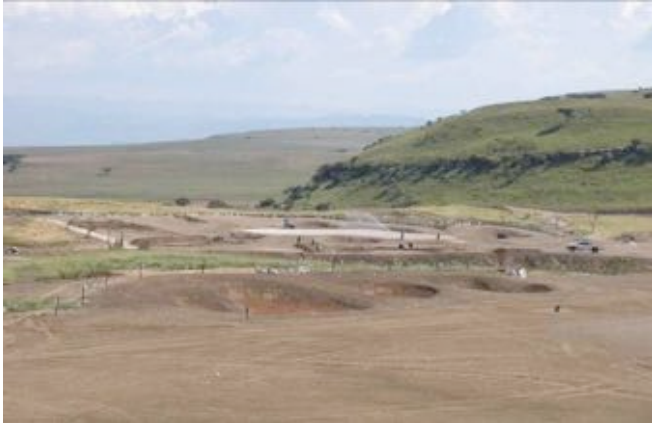
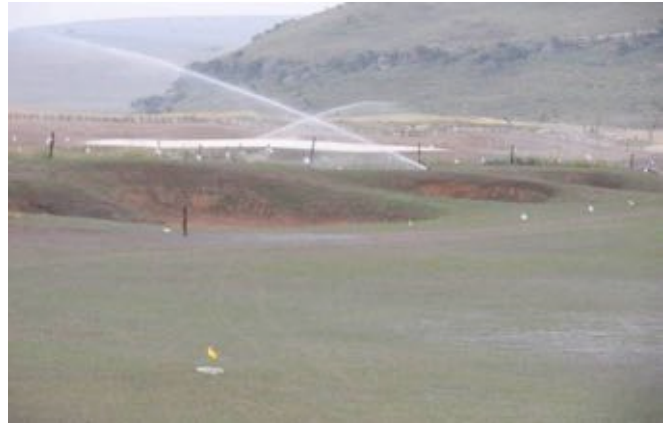
Hole 13 Complex of 3 Fairway Bunkers

Additional topsoil is required to assist with germination over certain areas.

Later in the week there was 27mm of rain causing no damage to the applied area except where the sprinkler head had not been repaired and the spray did not cure, there was also a small patch of about 500mm² where the face collapsed due to insufficient compaction and placement of the topsoil.

Only areas without germination were due to an insufficient amount of topsoil placement.

April 2, 2009 after application

April 20, 2009 showing germination

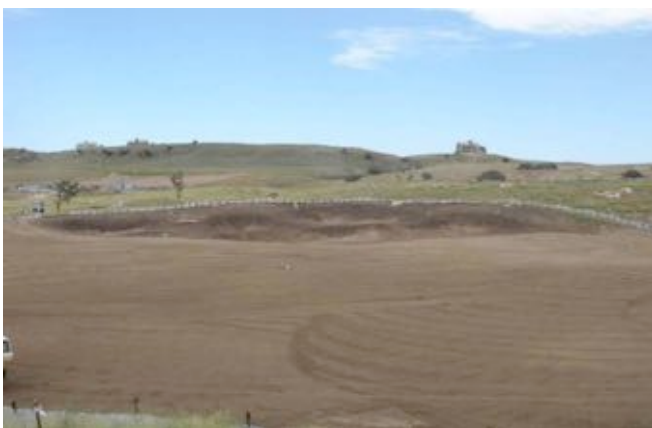
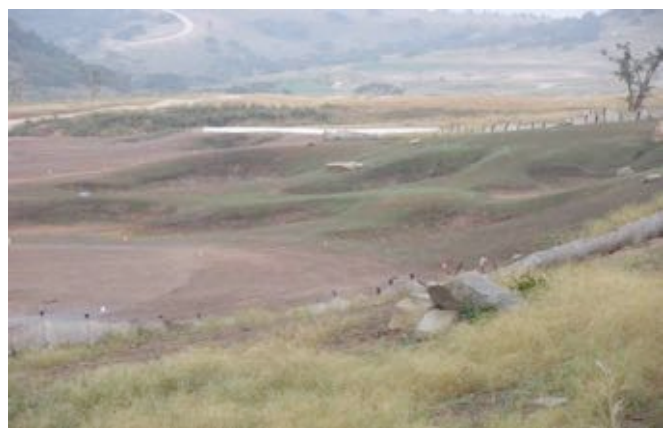
Hole 13 Complex of 5 Fairway Bunkers

Later in the week there was 27mm of rain and causing no damage except where a small patch where the silt fence overflowed and created a small wash out.

Only areas without germination were due to an insufficient amount of topsoil placement.

There is an area behind the silt fence that is acting as a catch pit for irrigation and rainwater, which is running through the silt fence and coming out by the rock and running into the bunker causing erosion and possible contamination. A proper drainage solution needs to be installed in this area.

April 2, 2009 after application

April 20, 2009 showing germination

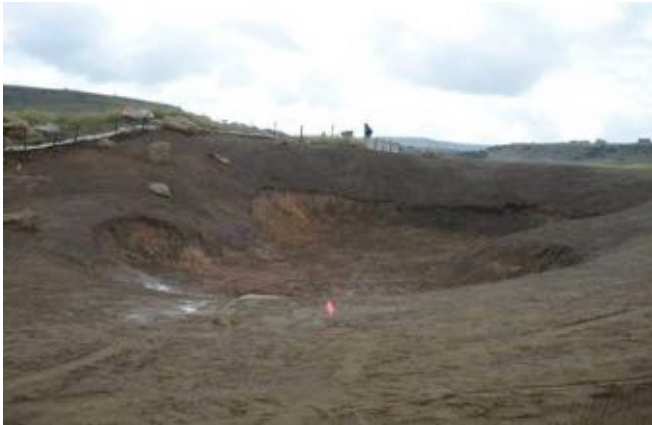
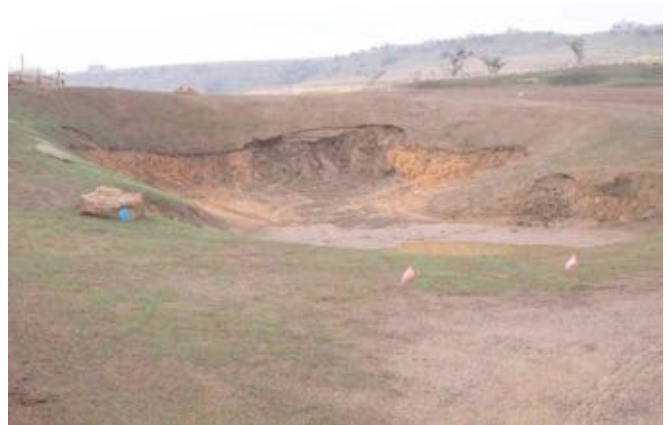
Hole 13 Hillside 1 Large Fairway Bunker

Prior to our initial site establishment and application the rain caused a large section of the bunker to collapse, the bunker was repaired and the topsoil replaced.

Later in the week there was 27mm of rain causing no damage except for a patch of about 1 m² where the face collapsed due to insufficient compaction and placement of the topsoil.

Only areas without germination were due to an insufficient amount of topsoil placement.

There are a few areas of the bunker face with erosion problems where the face actually collapsed from previous rains that have not been repaired as of yet.

April 3, 2009 after application

April 20, 2009 showing germination

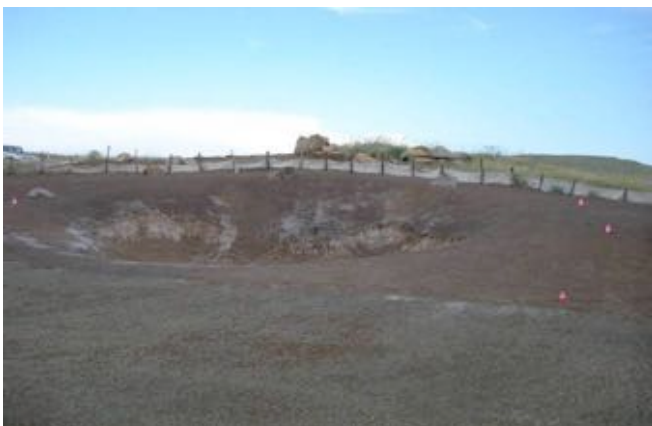
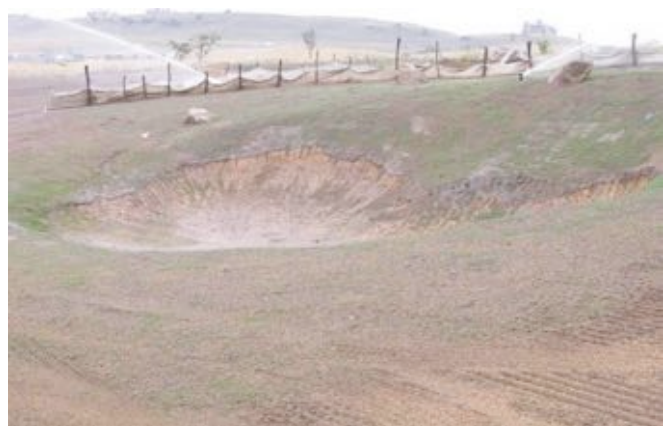
Hole 12 Hillside 1 Large Fairway Bunker

Requires additional topsoil to assist with germination.

Only areas without germination were due to an insufficient amount of topsoil placement.

April 3, 2009 after application

April 20, 2009 showing germination

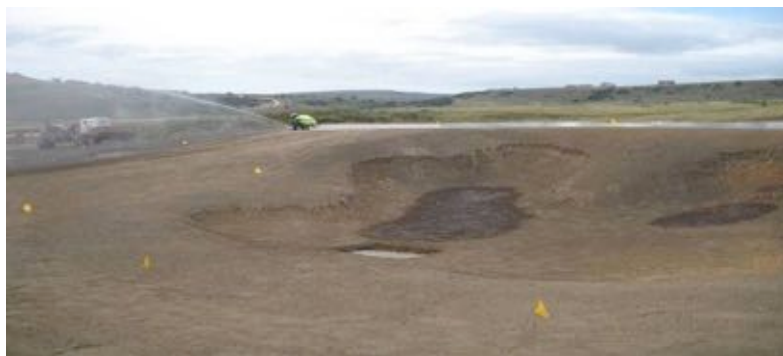
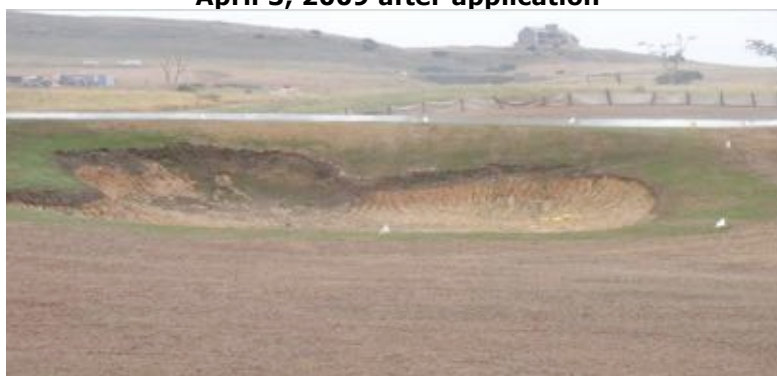
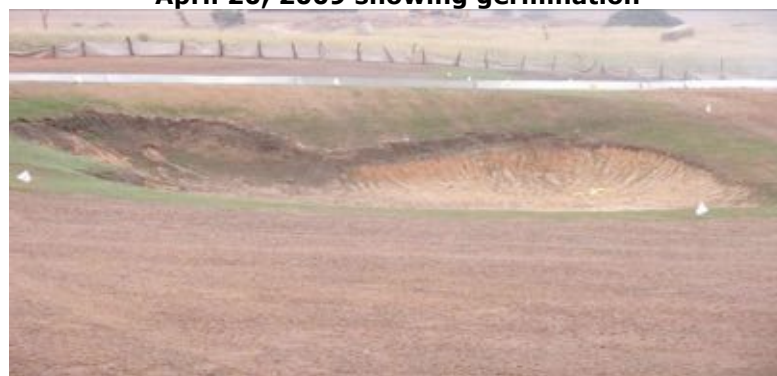
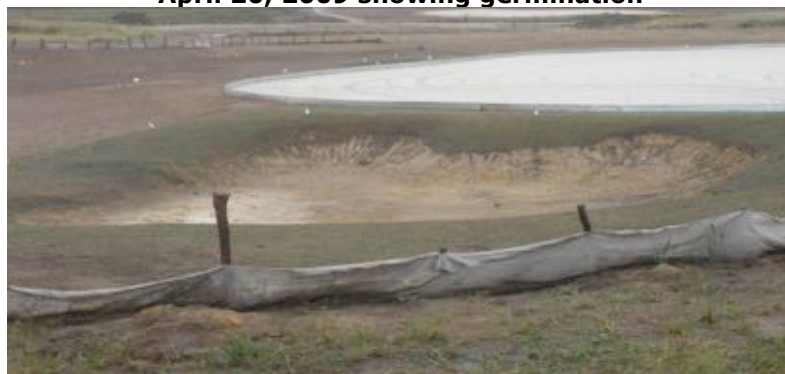
Hole 13 Complex of 3 Greenside Bunkers

Only areas without germination were due to an insufficient amount of topsoil placement.

April 3, 2009 after application

April 20, 2009 showing germination

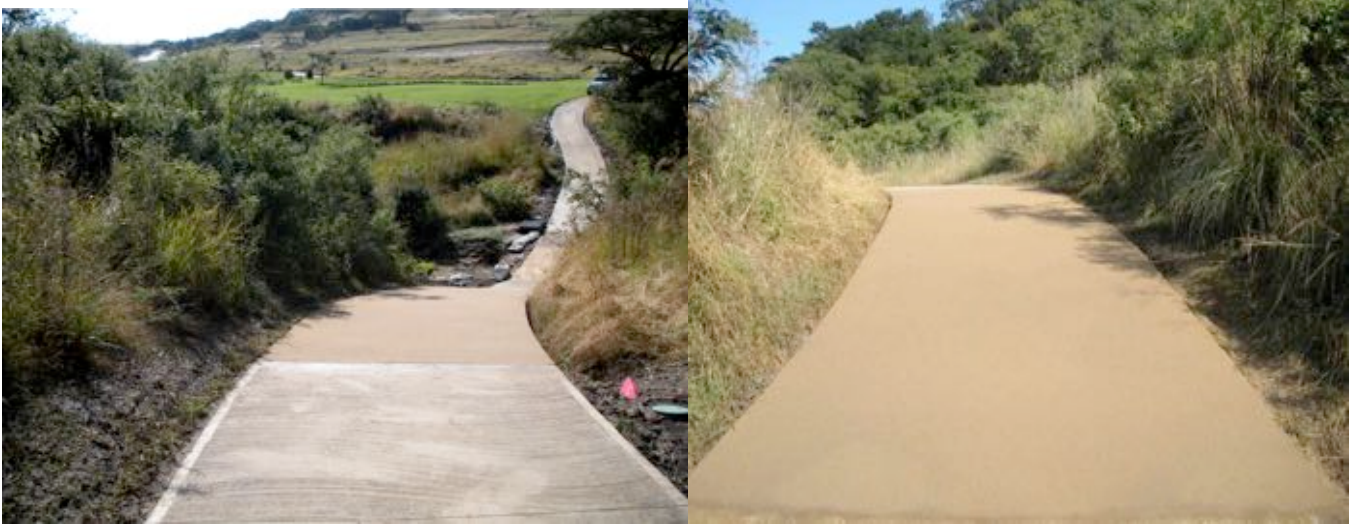
Hole 18 Tee Box Cart Path

On April 4th and 5th we completed a trial cart path section introducing nature's path™
The total trial area is 2.5meters x 12 meters and to date has had traffic, rain and no damage.

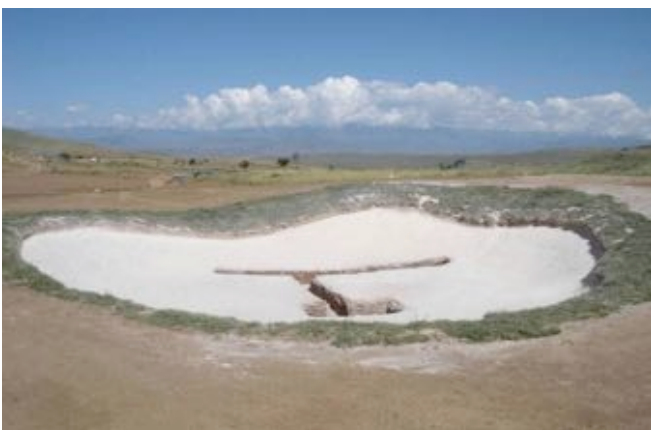
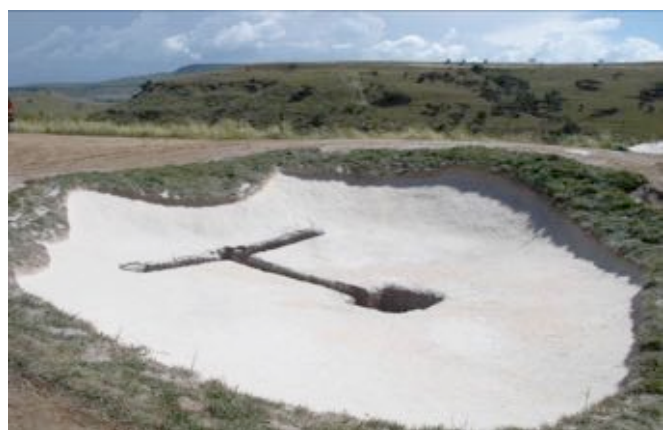
Hole 2 Complex of 3 Fairway Bunkers

1 hour after completion there was 27 mm rain and 50 – 60% of the work was lost as the rain came before the bunkers had a chance to dry.

The large holes left by the pegs from the sod installation created an unexpected drainage issue so they were filled in and sealed to prevent contamination.

The same holes caused water ingress through the wall of the bunker base and have now been plugged.

They have now been prepared again and treated with the first two coats of bunker lining treatment.

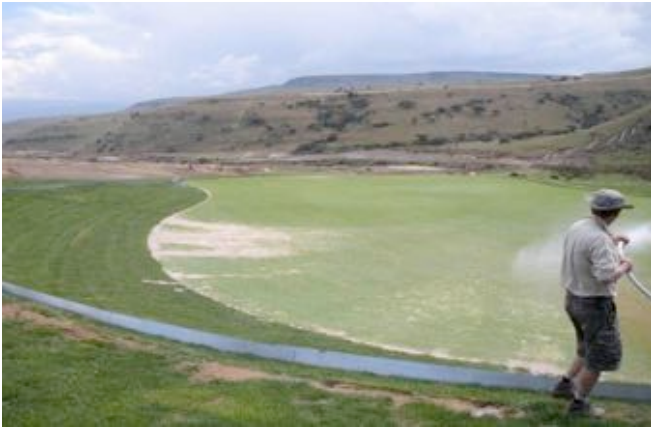
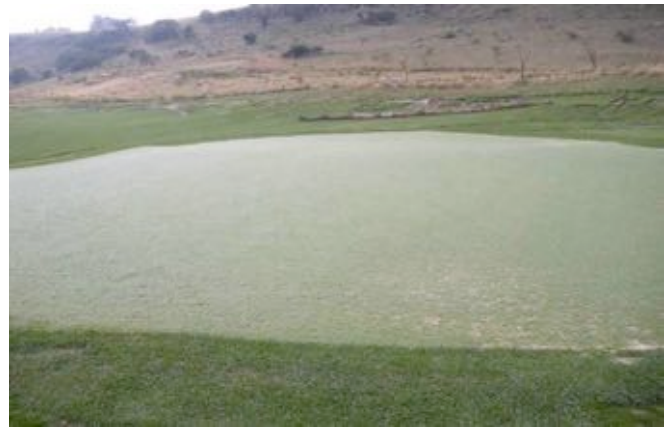
Hole 1 Green

Upon finishing the work on the two bunkers on hole 2, there was excess material that was requested by Wallington Turf to be applied as erosion control for the Hole 1 green which was consented to and completed.

April 8, 2009 during application

April 20, 2009

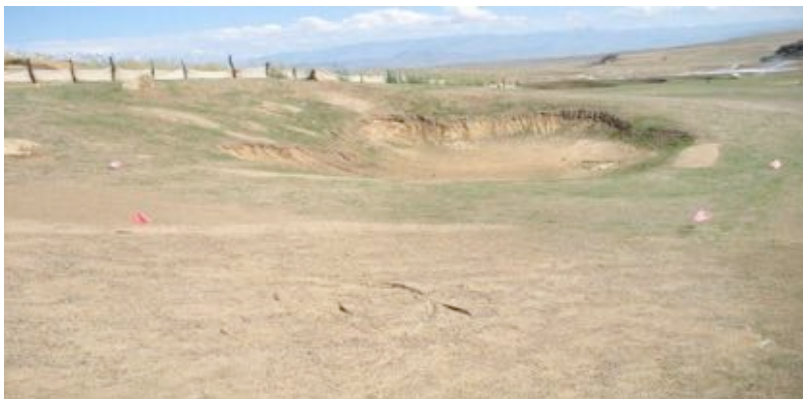
Hole 12 Hillside 1 Large Fairway Bunker prepared for repair

The areas in need of repair were areas where an insufficient amount of topsoil was placed and germination did not occur. Preparation of these areas included spiking of the clay area, mixing of topsoil and seed, raking of the topsoil and seed and then pre-wetting of the area to be treated.
