Ernie Els Design
Nondela – Drakensberg Mountain Estate
Progress Report

On-Course Solutions site establishes at Nondela for Hydro-seeding, Bunker Stabilization and a Cart Path Trial Section

Site Establishment – March 30, 2009

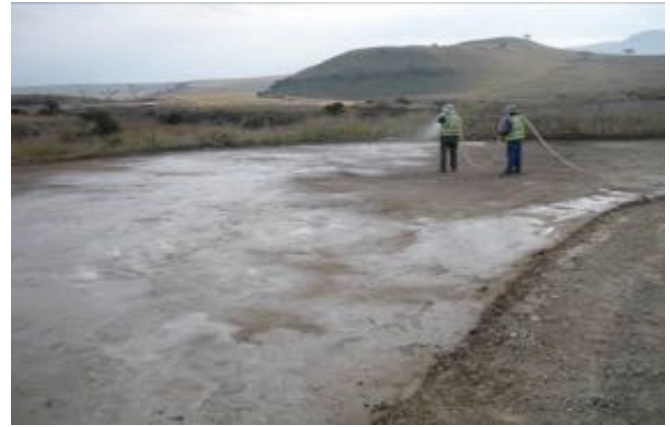
Training on hole 10 green

For additional training we moved to a green on hole 10 which needed to be watered prior to compaction. This was a perfect area for training of the short, medium and long-range methods of spraying and how best to adjust the spray nozzle when moving between the different ranges.

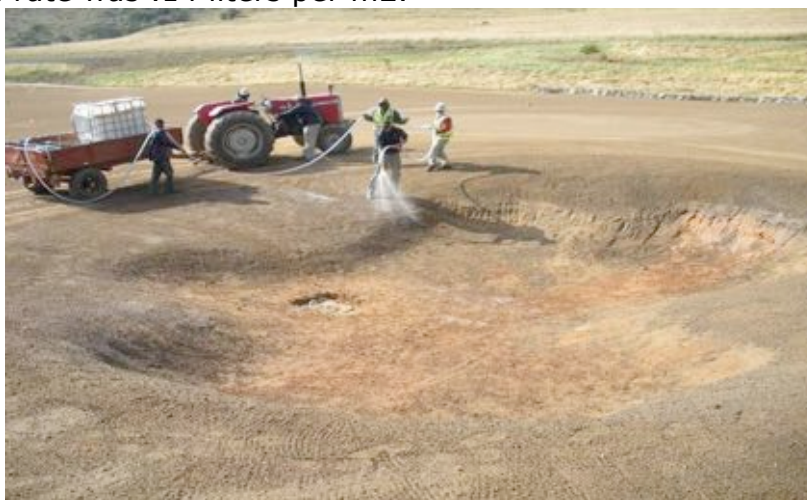
Hole 2 Bunker Complex with 4 Bunkers

The total approximate area treated was 545 m².

The final application rate was .06 liters per m².

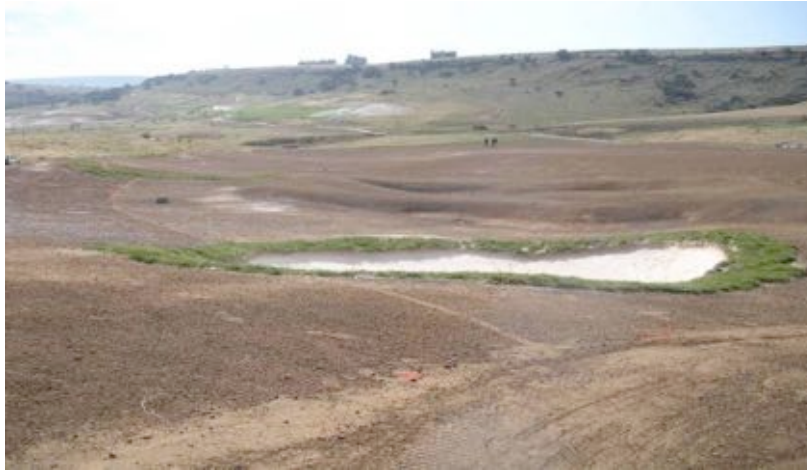
Hole 2 Bunker to Side of Green along Grass Line

The total approximate area treated was 90 m².

The final application rate was .11 liters per m².

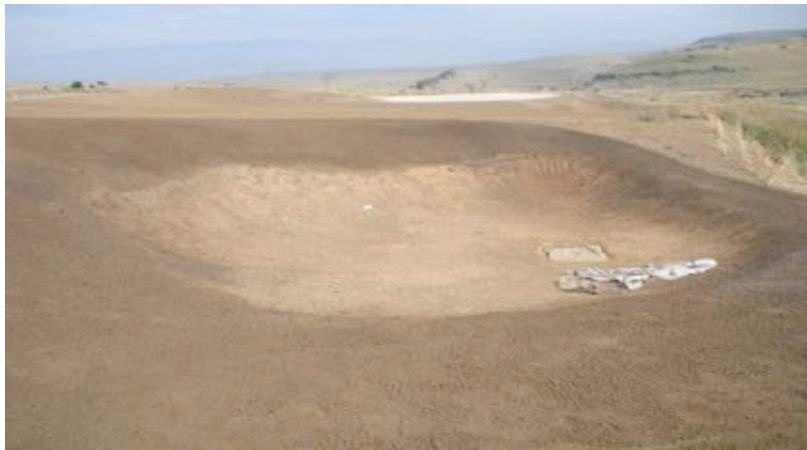
Hole 2 Large Fairway Bunker Furthest From Green

The total approximate area treated was 420 m².

The final application rate was .05 liters per m².

A silt fence was installed all along the high side of the bunker.

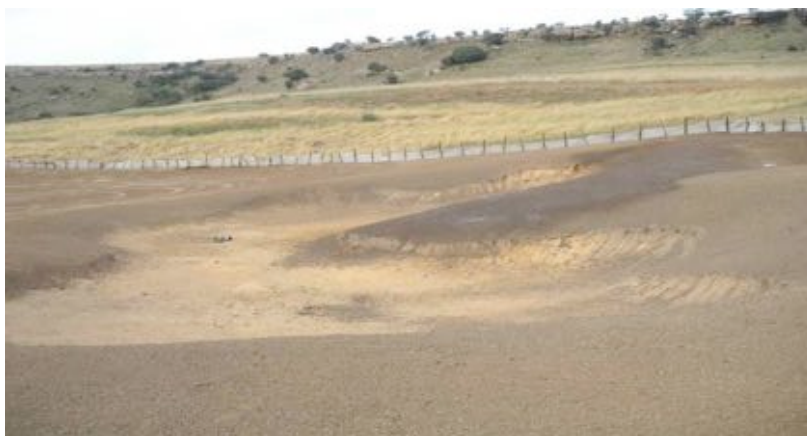
Hole 2 Middle Fairway Bunker along Silt Fence

The total approximate area treated was 230 m².

The final application rate was .08 liters per m².

A silt fence was installed all along the high side of the bunker.

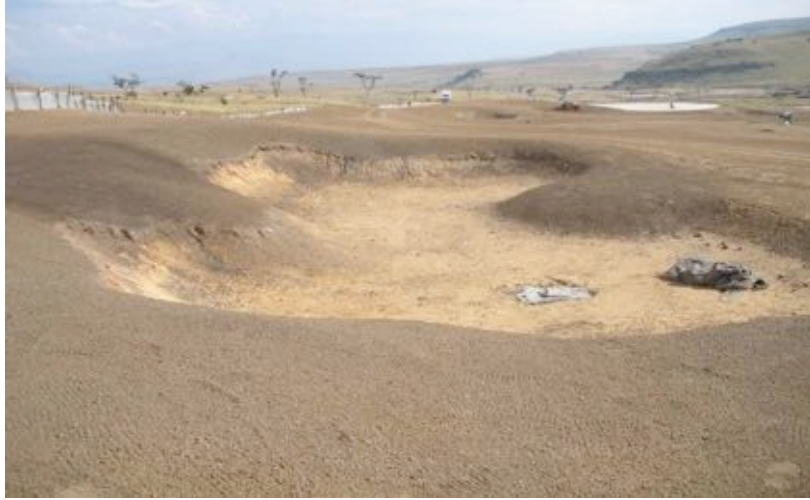
Hole 2 Small Pot Bunker Near Green

The total approximate area treated was 66 m².

The final application rate was .11 liters per m².

A silt fence was installed all along the high side of the bunker.

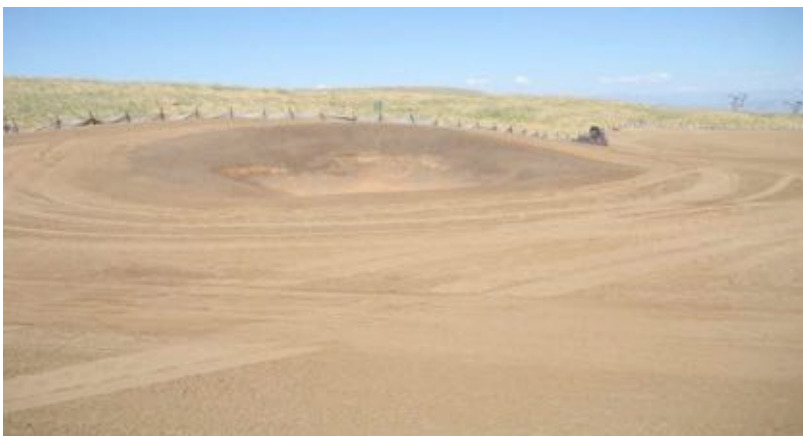
Hole 15 Pot Bunker 1

A silt fence was installed all along the high side of the bunker.
The total approximate area treated was 70 m².
The final application rate was .07 liters per m².

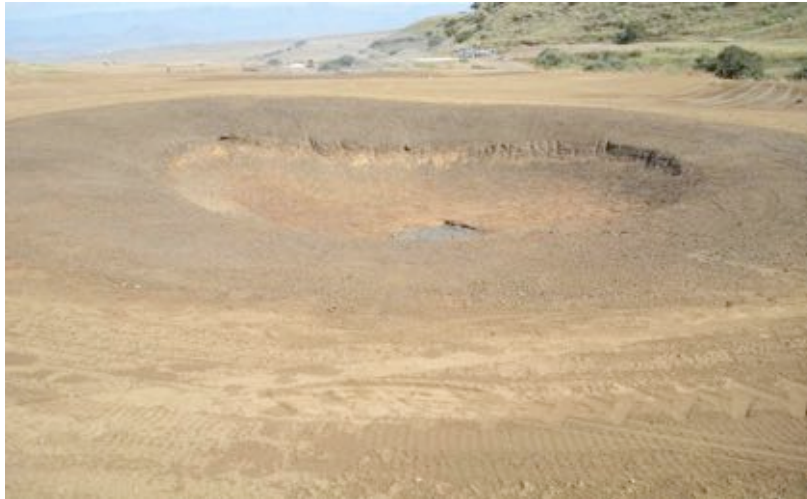
Hole 15 Pot Bunker 2

The total approximate area treated was 50 m².
The final application rate was .08 liters per m².

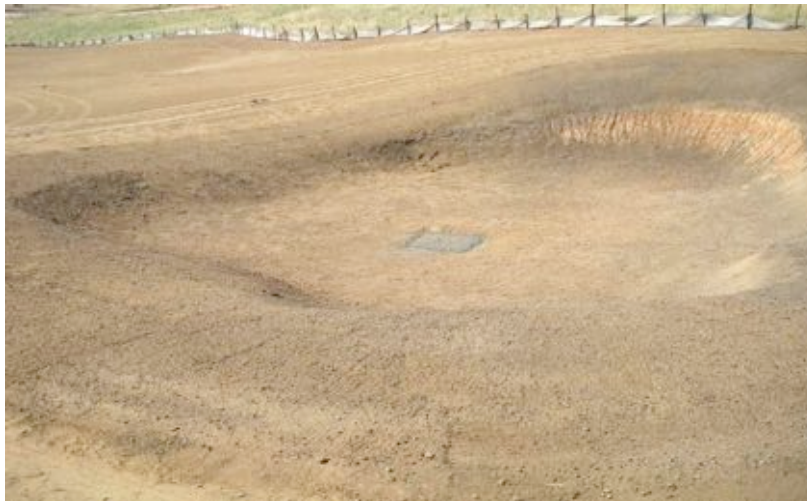
Hole 15 Pot Bunker 3

A silt fence was installed all along the high side of the bunker.
The total approximate area treated was 50 m².
The final application rate was .08 liters per m².
